RSR BOARD OF INQUIRY REPORT	
OPERATOR	PRASA RAIL
PERMIT NUMBER	ASP0002NTS
INVESTIGATION SUBJECT	PRASA RAIL DENVER STATION REAR-END COLLISION OF 28 APRIL 2015
DATE OF OCCURENCE	28 APRIL 2015
REFERENCE NUMBER	RSR/20150428/011

- 1.3. This Board of Inquiry was mandated to investigate and examine the cause of the collision involving Metroplus Express Train 0600 and Business Express Train 1602 at the Denver Station, Johannesburg on 28 April 2015 at around 07h10. Both trains are operated by PRASA Rail.

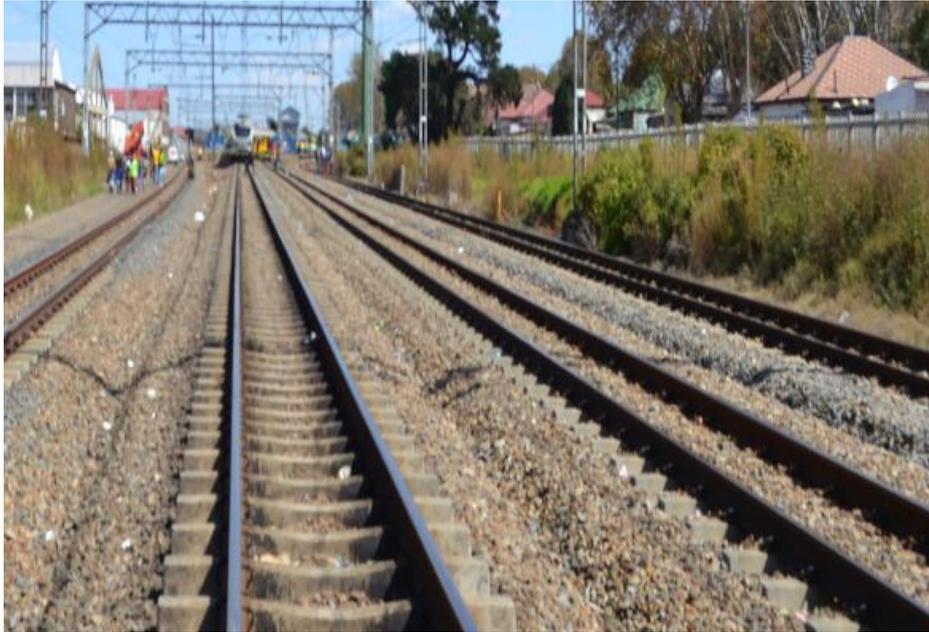
Figure 1: View of point of incident from Toronga side

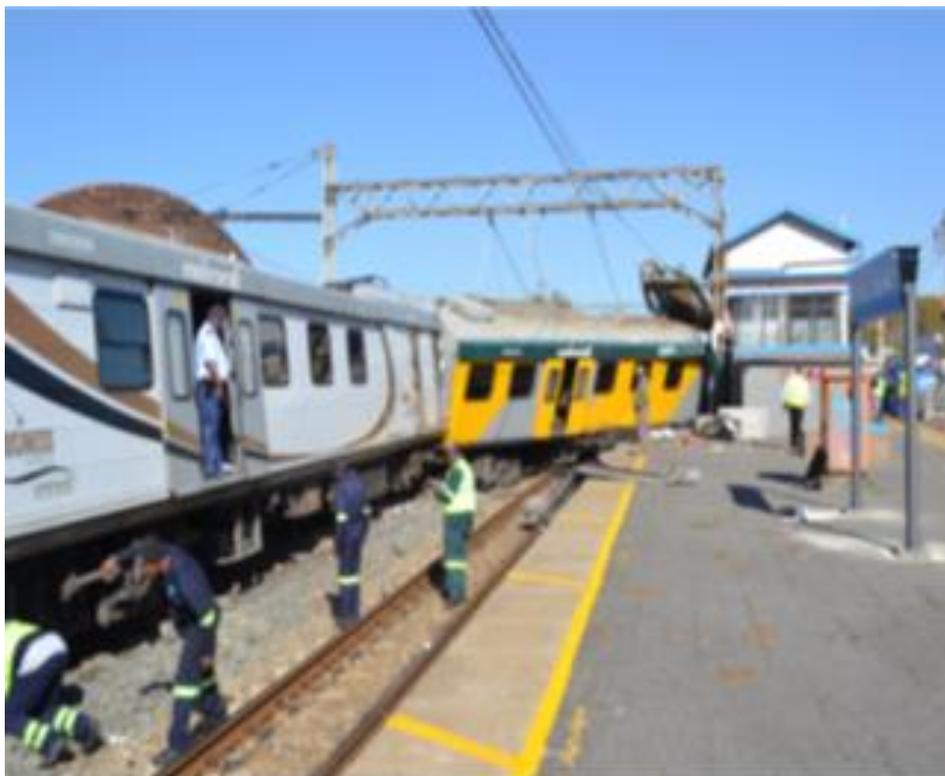
Figure 2: Damage to the leading motor coach of Business Express Train 1602

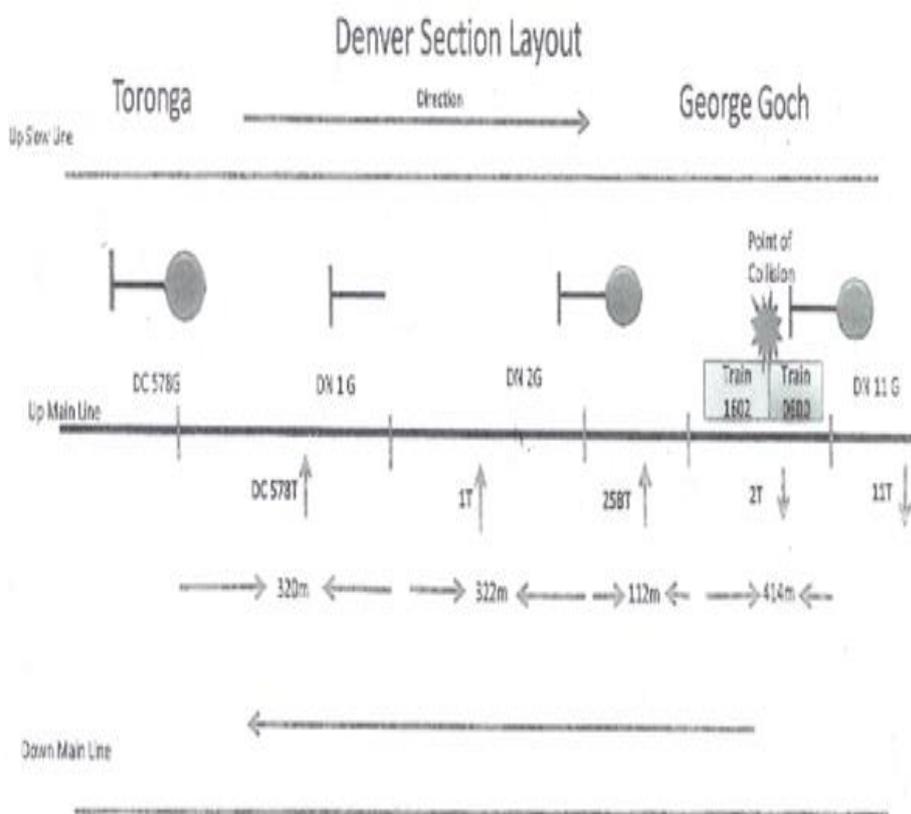
Figure 3 : Denver Section layout showing the location of the incident

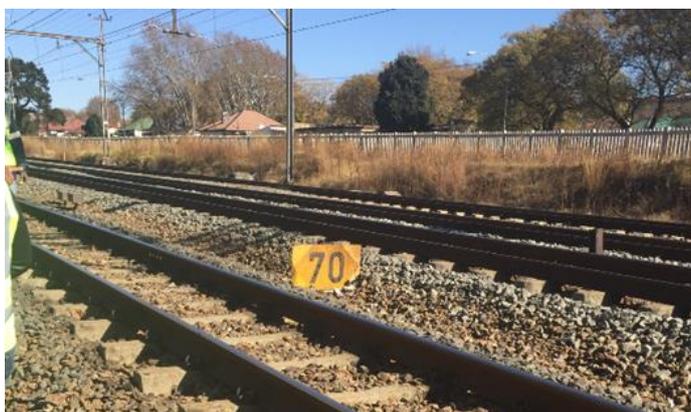
Figure 4: Speed limit just before point of incident
